WADC TECHNICAL REPORT 54-492

OXIDATION-RESISTANT COATINGS FOR MOLYBDENUM

CLIMAX MOLYBDENUM COMPANY OF MICHIGAN

DECEMBER 1954

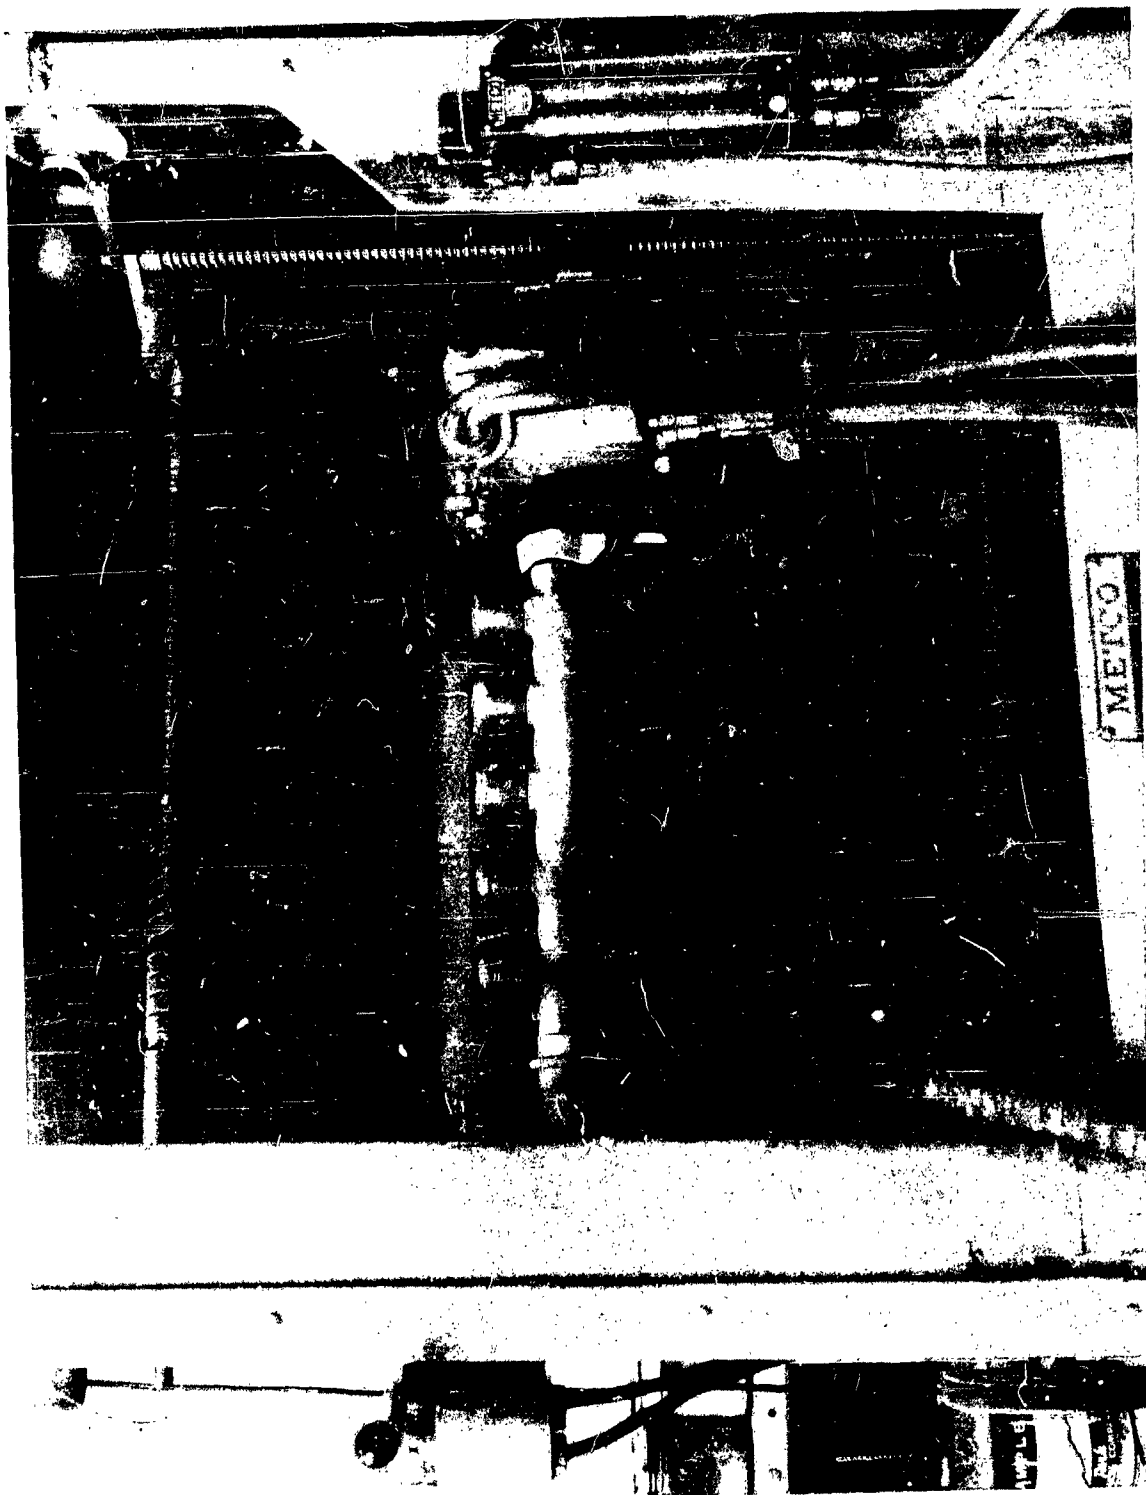
FIG 2 (P11144) - EQUIPMENT IN POSITION FOR SPRAY COATING EDGES OF PANELS

The edges of the panels are coated as follows: two edges, the edge facing the gun and an adjacent edge, are sprayed with the panels in a horizontal plane as shown in Figure 2. By turning the manifold 180 degrees on its longitudinal axis, the panels can be held in a second horizontal plane, below the axis of the manifold, and the remaining two edges of each panel are sprayed. Although the panels are now below the opening of the sleeve, the vacuum cleaner maintains a pressure differential sufficient to support the weight of a panel and to prevent it from moving during the spraying operation.

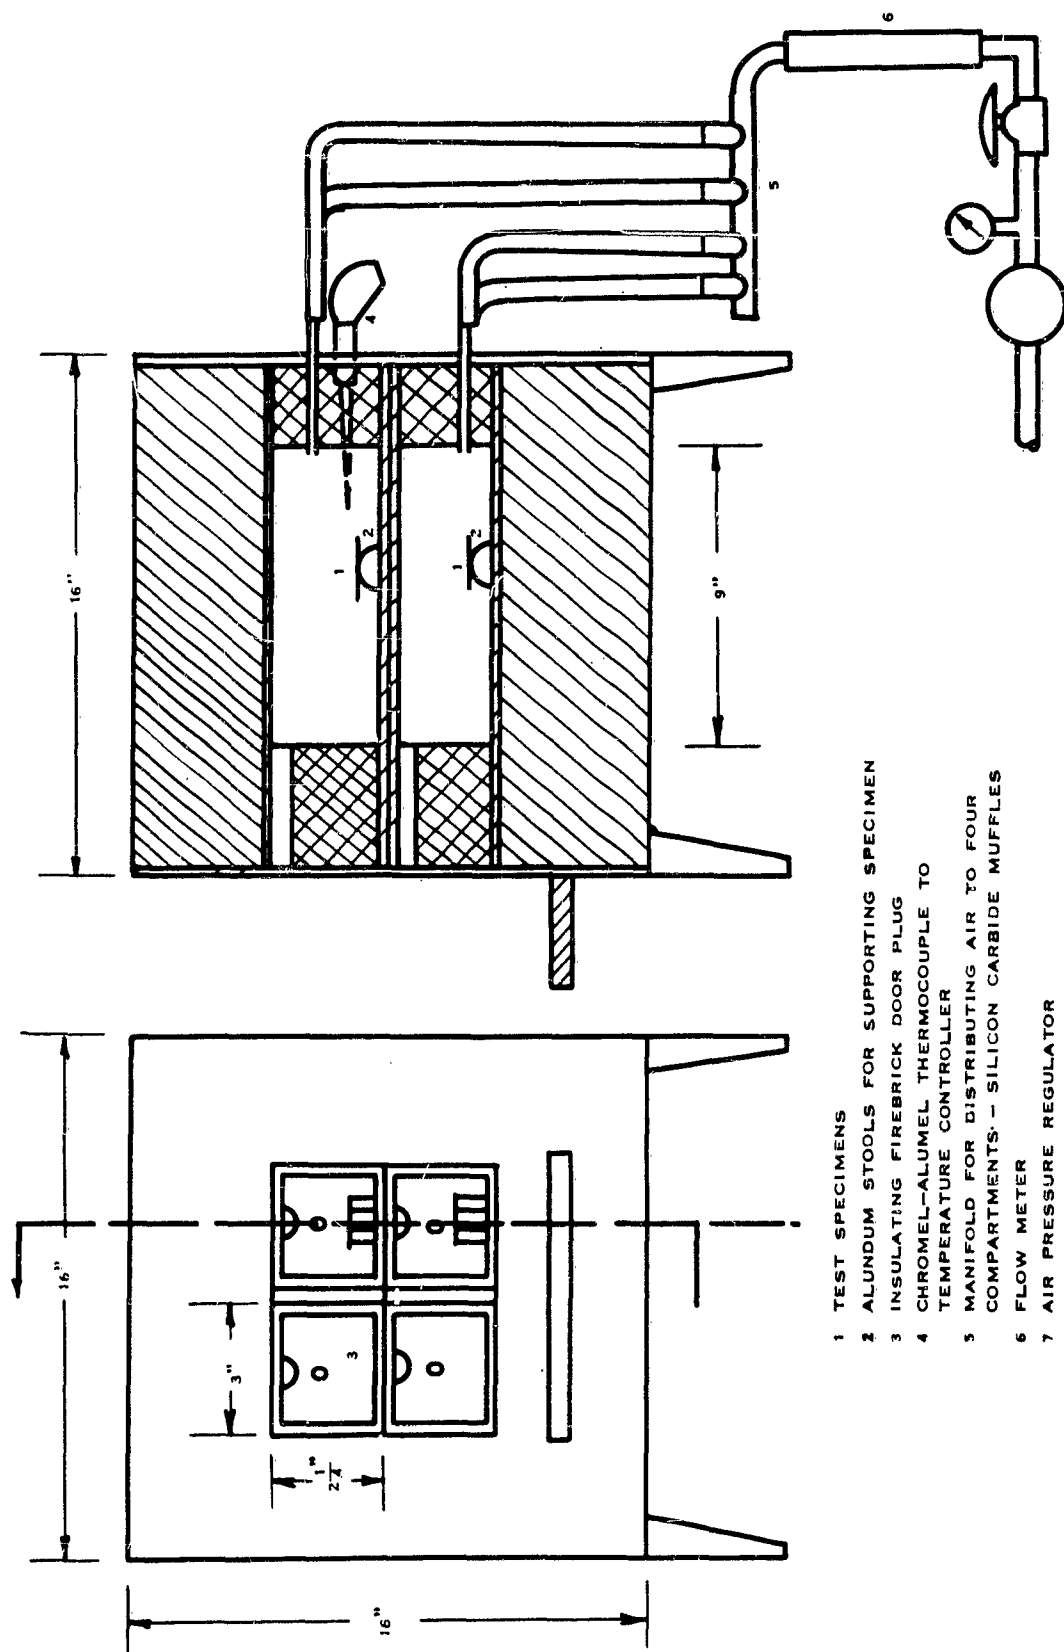
- 1 TEST SPECIMENS
- 2 ALUMINA STOOLS FOR SUPPORTING SPECIMEN
- 3 INSULATING FIREBRICK DOOR PLUG
- 4 CHROMEL-ALUMEL THERMOCOUPLE TO TEMPERATURE CONTROLLER
- 5 MANIFOLD FOR DISTRIBUTING AIR TO FOUR COMPARTMENTS - SILICON CARBIDE MUFFLES
- 6 FLOW METER
- 7 AIR PRESSURE REGULATOR

FIGURE 3 -- OXIDATION TEST FURNACE WITH FOUR SEPARATE COMPARTMENTS

HOSKINS ELECTRIC MUFFLE FURNACE TYPE FH-204
(689)

The specimen is placed in a separate compartment in an electrically-heated muffle furnace. Tests in this laboratory and at other research laboratories have indicated that molybdic oxide may react with certain metals or metallic oxides to accelerate oxidation. A failure of one type of coating in a furnace would permit the generation of MoO_3 which might react with another coated specimen and cause a premature failure, resulting in a false evaluation. Testing in separate compartments assures accurate evaluations since the only atmosphere responsible for failure is unadulterated air.

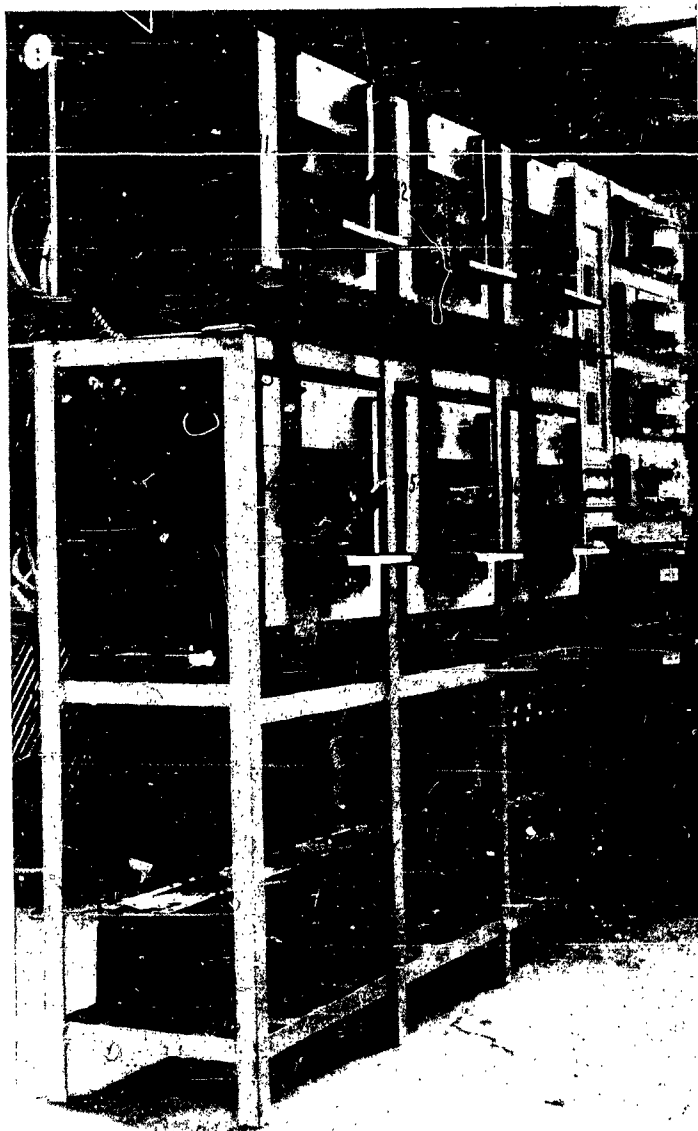
FIG 4 (P1142) - FRONT VIEW OF SIX FURNACES FOR
CONDUCTING OXIDATION TESTS IN
AIR AT 1800°F

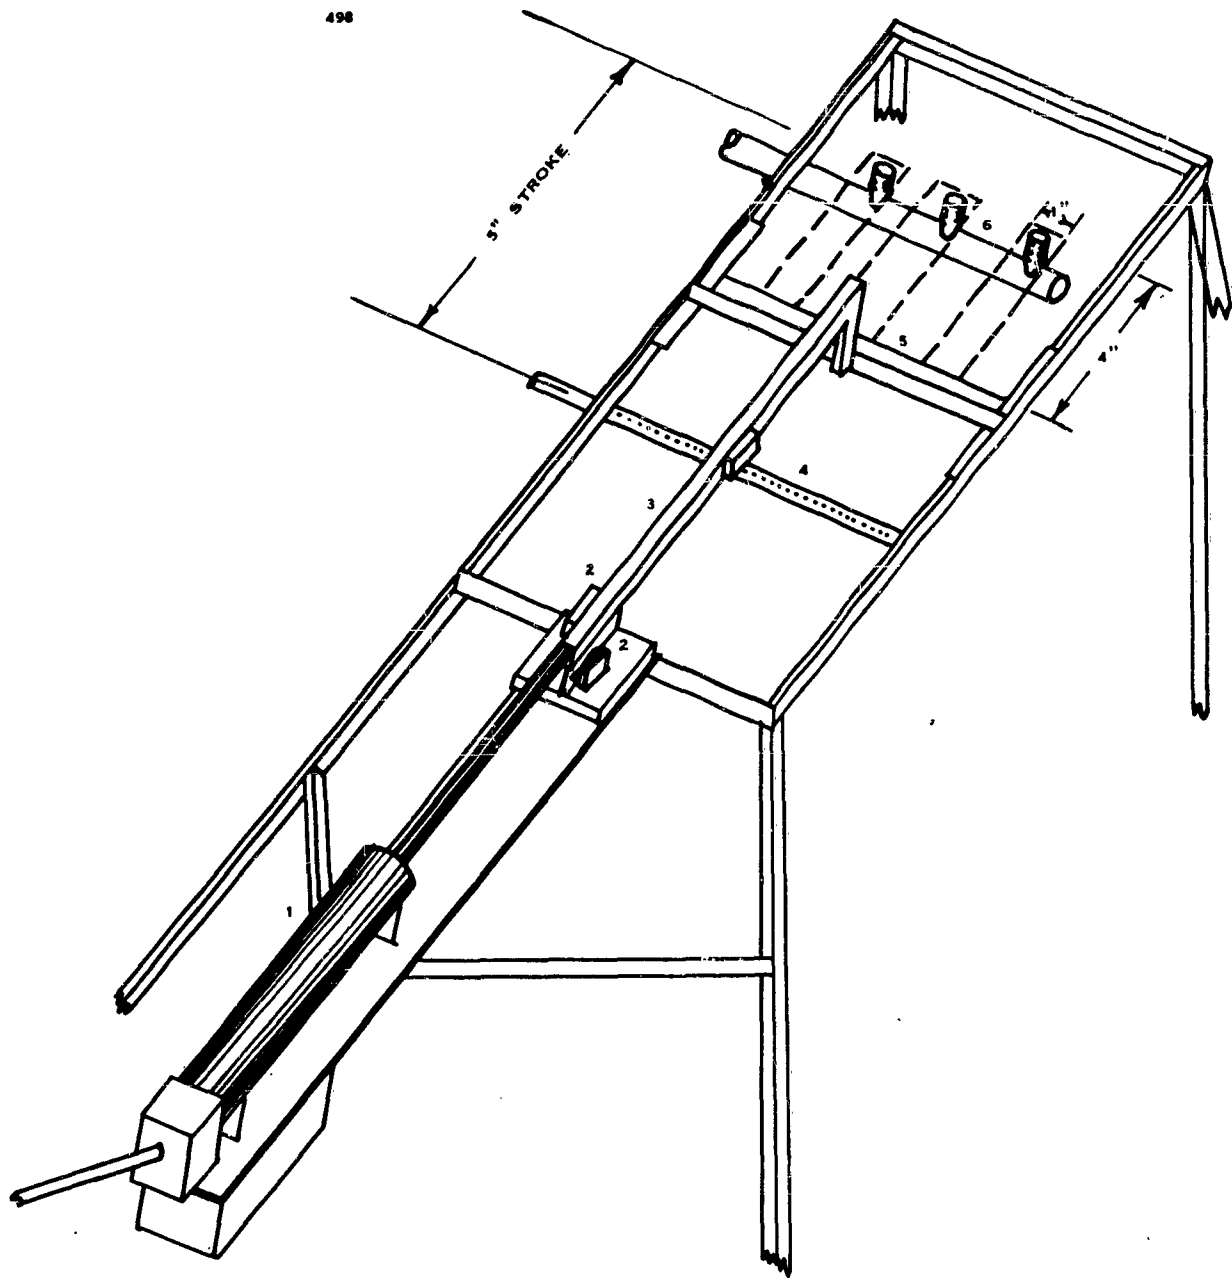
1. AIR MOTOR WITH PISTON OF 5" STROKE
2. LIMIT MICROSWITCHES
3. TRANSITE PISTON EXTENSION
4. VENTED AIR-COOLING MANIFOLD
5. SLED MOUNTING FOR THREE TEST SPECIMENS
6. GAS-AIR MANIFOLD WITH THREE BURNERS
PRESSURE REGULATION 30-35 PSI

FIGURE 6 — THERMAL CYCLING APPARATUS

Although the thermal shock tests were severe in cooling, the reheating rate was not so severe. A special thermal-cycling apparatus was constructed to incorporate drastic heating and cooling. The apparatus comprises a device for heating three coated specimens 4 in. by 1 in. by 0.050 in. simultaneously in separate gas flames to 1800°F, removing the specimens from the flame, and cooling them to about 80°F in an air blast. A section approximately one inch square at one end of each specimen is heated in the flame produced by a one-inch-diameter blast tip burning natural gas with compressed air. The cycling is performed automatically with an air-operated motor and time-delay relays. Every 10 cycles the specimens are allowed to cool in still air so that failures might be detected.

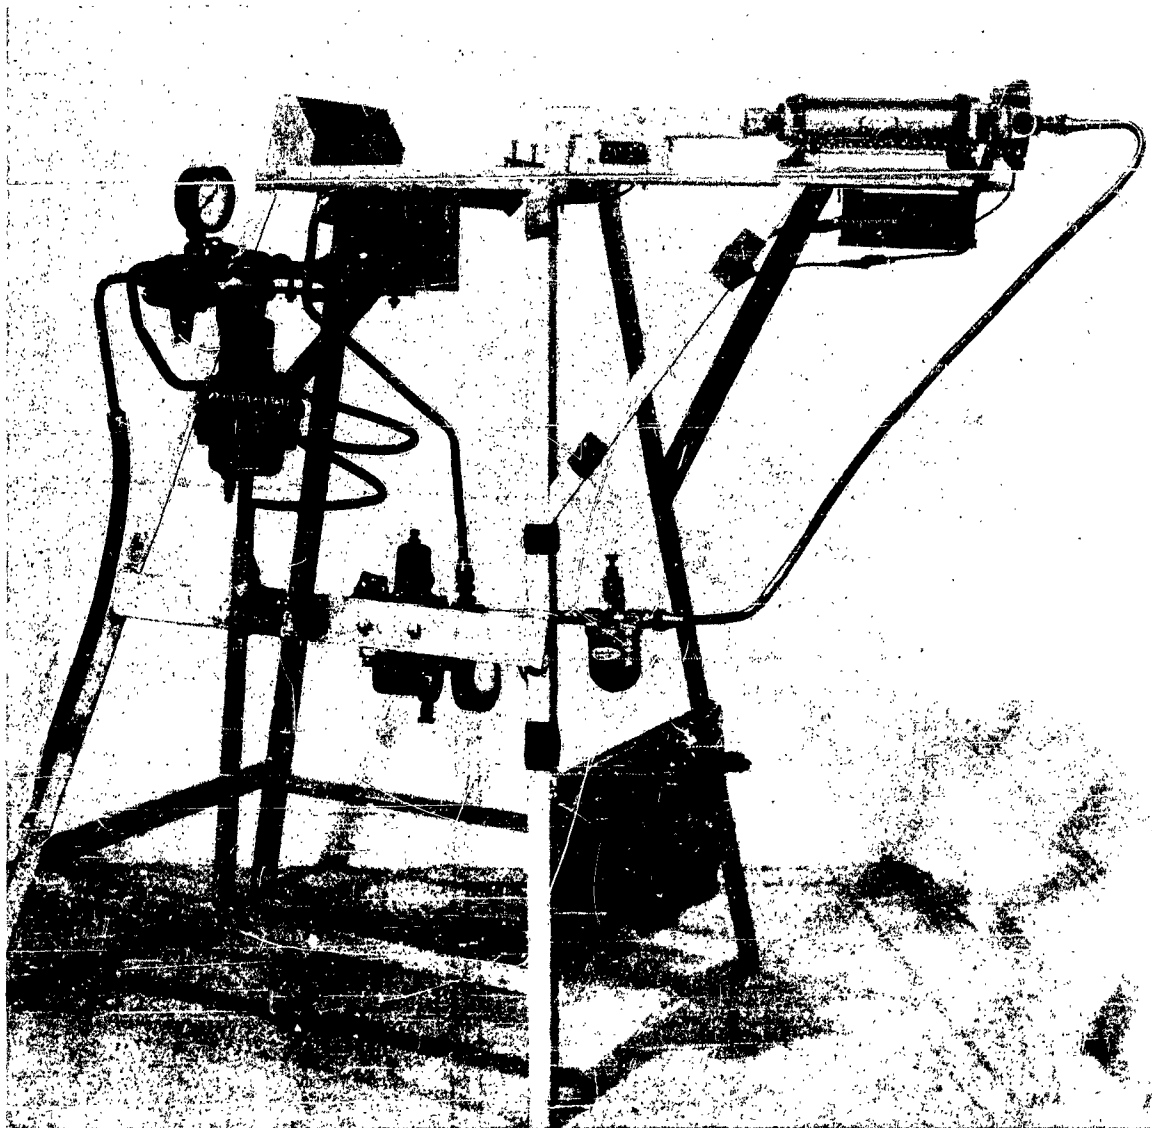
FIG 7 (P1067) - FRONT VIEW OF THERMAL CYCLING APPARATUS

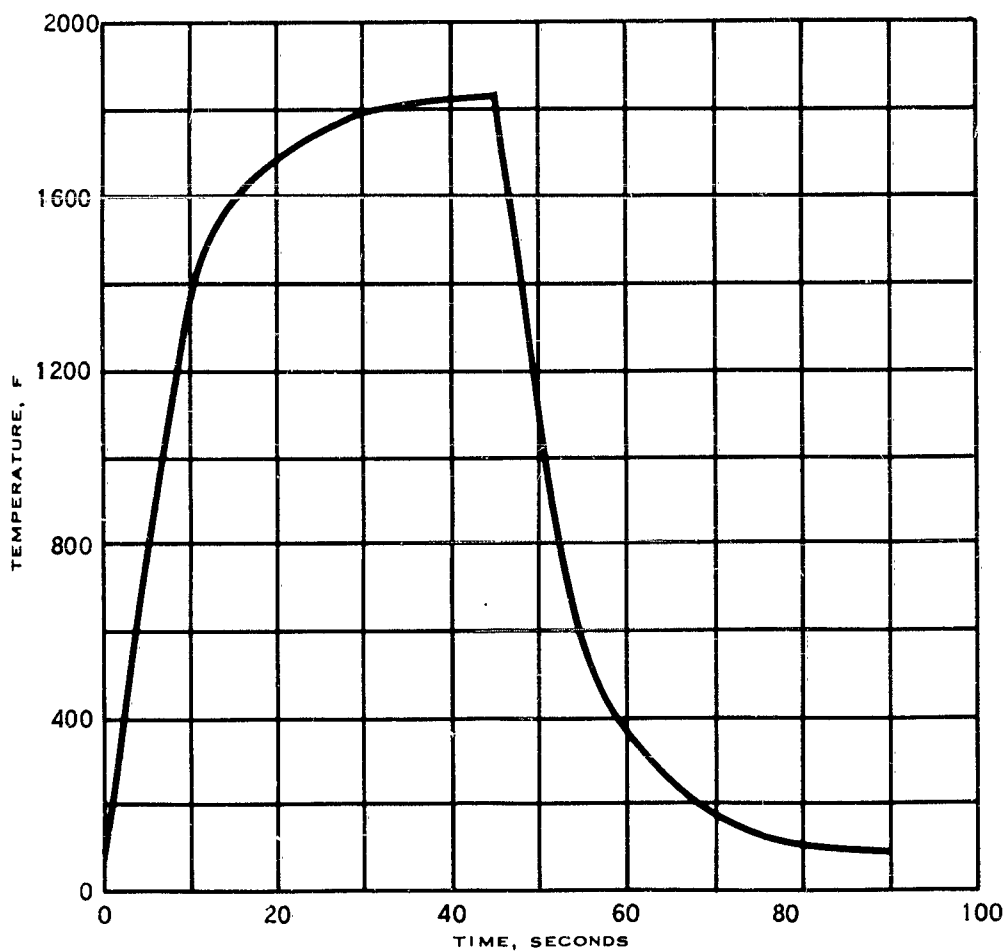
FIGURE 9 — HEATING AND COOLING CURVE OF SPECIMEN
IN CYCLIC THERMAL SHOCK TEST

SPRAY COATED MOLYBDENUM SPECIMEN
4 IN. BY 1 IN. BY 0.055 IN.

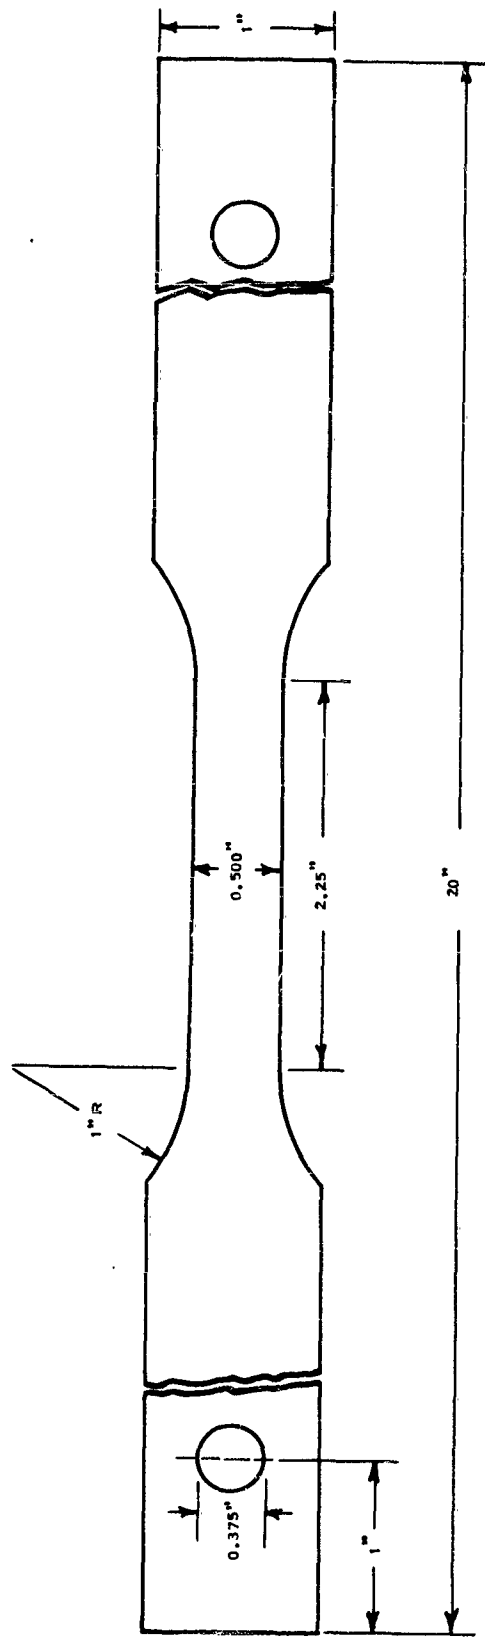
FIGURE 10 — CREEP-RUPTURE SHEET SPECIMEN FOR DUCTILITY TESTS

Two methods of testing the ductility of coated molybdenum have been employed. With both methods a sheet-type creep-rupture specimen shown in the sketch of Figure 10 was employed. The specimen was coated to within two inches of each end. Stress was applied through pins in holes in the uncoated ends; these ends extended out of the heating furnace sufficiently to be unoxidized during testing. In one test the specimen was loaded in a tensile testing machine and the gage section stressed in air at 1800°F sufficiently during a two- to three-hour period to produce a 2% elongation. The specimen was removed from the test and then the gage section was subjected to a standard oxidation test at 1800°F in the unstressed condition. The specimen was removed daily from the furnace for visual inspection. This test was continued for a 100-hour period at 1800°F.

Stress-rupture tests were conducted in air at 1800° and 2000°F with coated unalloyed molybdenum sheet specimens similar in dimensions to the ductility-test specimen of Figure 10; the single-layer aluminum-chromium-silicon and the Colmonoy No. 5 alloy coatings were employed. The data obtained are given in Table 3 and Figure 11. Table 3B shows that the stresses required for rupture in 1, 10, 50 and 100 hours at 1800°F with both coatings in air were comparable to the stresses required to rupture uncoated molybdenum

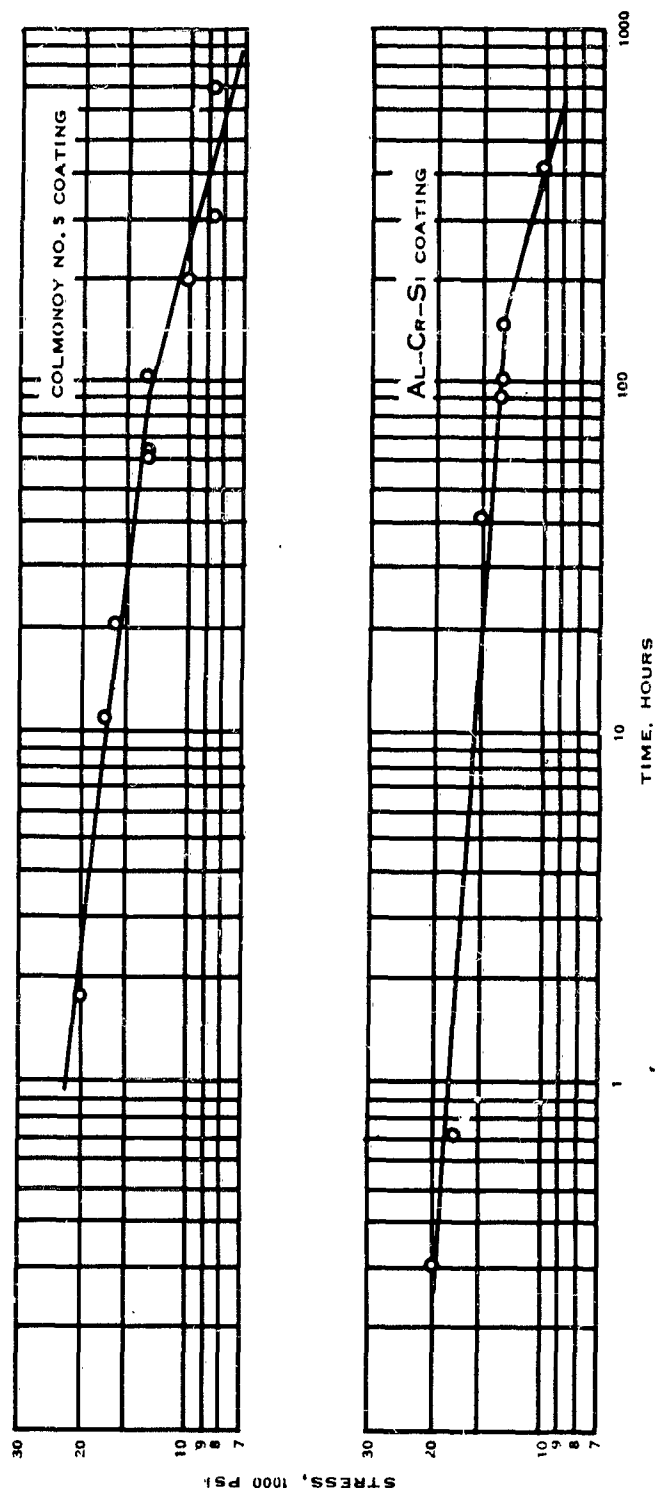
FIGURE 11 - STRESS RUPTURE PROPERTIES OF COATED MOLYBDENUM SHEET AT 1800° F

^{1/} Values from curve of Figure 11^{2/} Arc-cast molybdenum-base alloys, Fourth Annual Report NR 039-002, by Climax Molybdenum Company of Michigan, 1953, by M. Semchyshen and R. Q. Barr

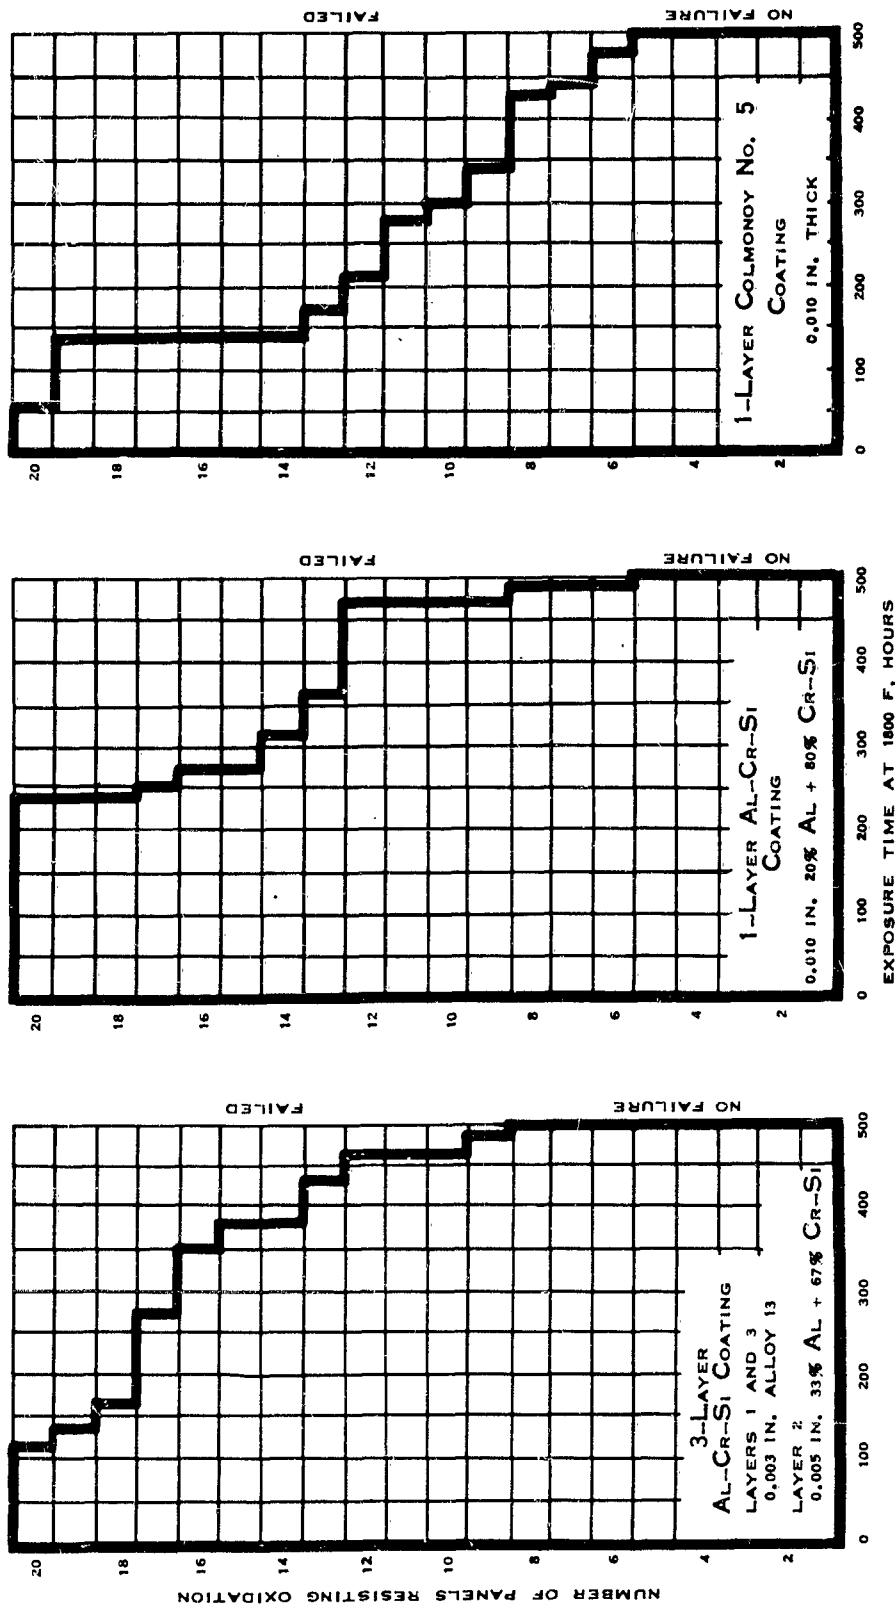
FIGURE 12 - FAILURE DISTRIBUTION CURVES FOR OXIDATION TESTS WITH THREE COATING COMPOSITIONS

PANELS WERE GRIT-BLASTED WITH ALUMINA AND MANUALLY SPRAYED

The results of the oxidation tests at 1800°F, given in Figure 12, show that more than 50% of the panels failed in less than 500 hours of testing, exhibiting very poor reproducibility of results. The cause of the numerous failures that occurred before the end of the 500-hour period was attributed to variables in the spray coating process. These were investigated; the results of the investigation are reported in the next section.

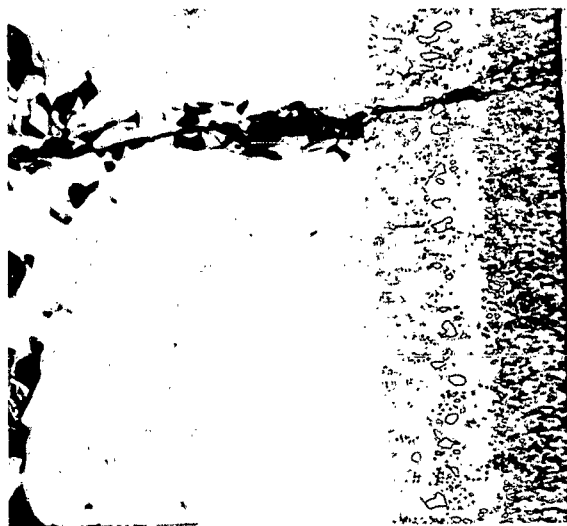
A. Diffusion Treated Two Hours in
Purified Hydrogen at 2000°F

FIG 13 - MICROSTRUCTURES OF Al-Cr-Si COATINGS ON MOLYBDENUM
AFTER DIFFUSION TREATING AND AFTER OXIDATION
TESTING IN AIR FOR 25 HOURS AT 1800°F

Coating cracks were purposely included in each of the photomicrographs of Figures 13-15 to show that within the 500-hour period of testing at 1800°F the molybdenum was not oxidized at the base of the cracks. Evidently the coating expands sufficiently upon heating to 1800°F that the cracks are closed, and thus air is prevented from gaining access to the molybdenum at 1800°F.

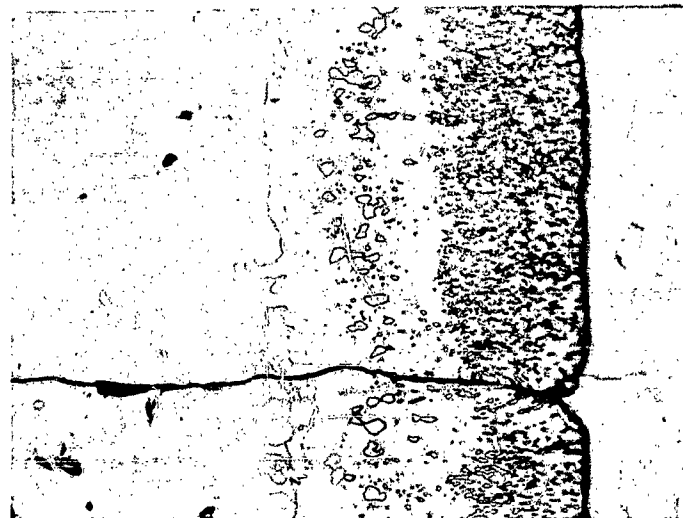
A. Oxidation Tested 50 Hours in
Air at 1800°F

FIG 14 - MICROSTRUCTURES OF Al-Cr-Si COATINGS ON MOLYBDENUM
AFTER OXIDATION TESTING IN AIR FOR 50 AND
100 HOURS AT 1800°F

The irregularity of the interface at the base of the crack in Figure 14B was caused by the presence of a small molybdenum carbide which interfered with the interdiffusion of the coating and molybdenum. This effect is illustrated more clearly with another specimen in Figure 16.

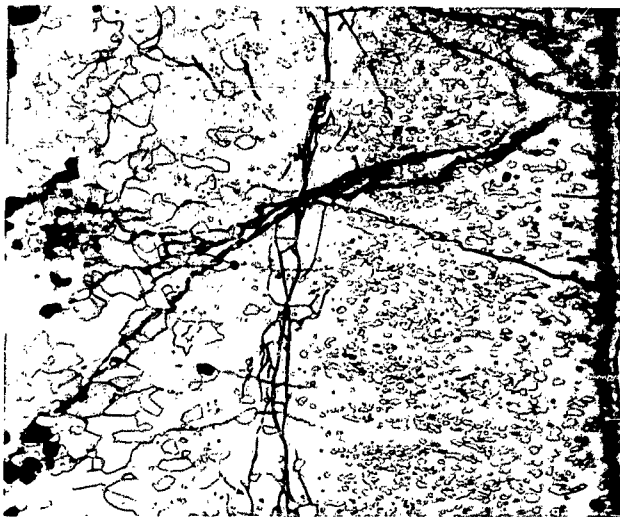
A. Oxidation Tested 200 Hours in
Air at 1800°F

B. Oxidation Tested 500 Hours in
Air at 1800°F

FIG 15 - MICROSTRUCTURES OF Al-Cr-Si COATINGS ON MOLYBDENUM
AFTER OXIDATION TESTING IN AIR FOR 200 AND
500 HOURS AT 1800°F

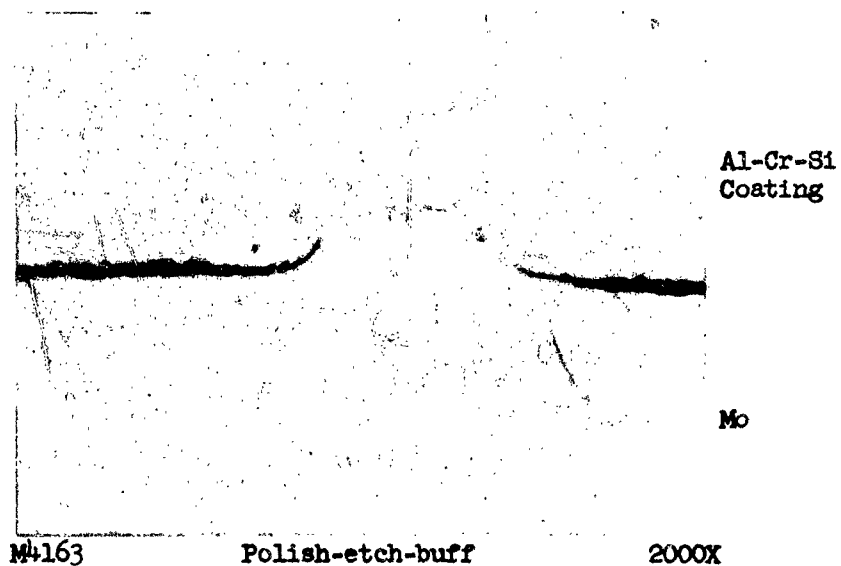
FIG 16 - MICROSTRUCTURE OF Al-Cr-Si COATING ON MOLYBDENUM
DIFFUSION TREATED TWO HOURS IN PURIFIED HYDROGEN
AT 2000°F, SHOWING MOLYBDENUM CARBIDE
INTERFERENCE WITH INTERDIFFUSION OF
COATING AND MOLYBDENUM

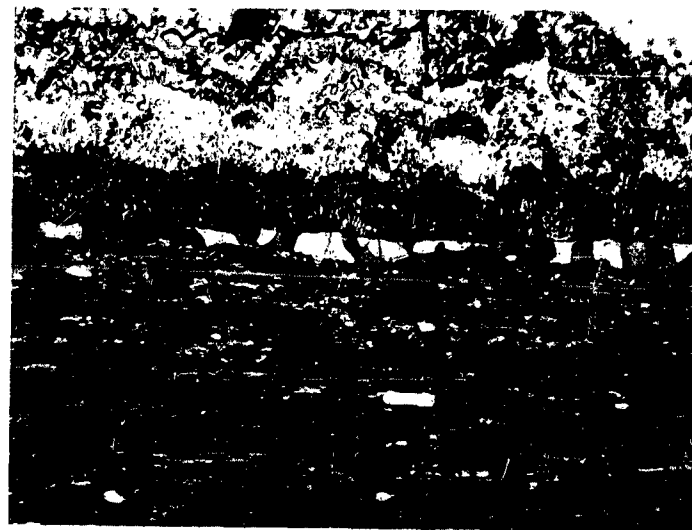
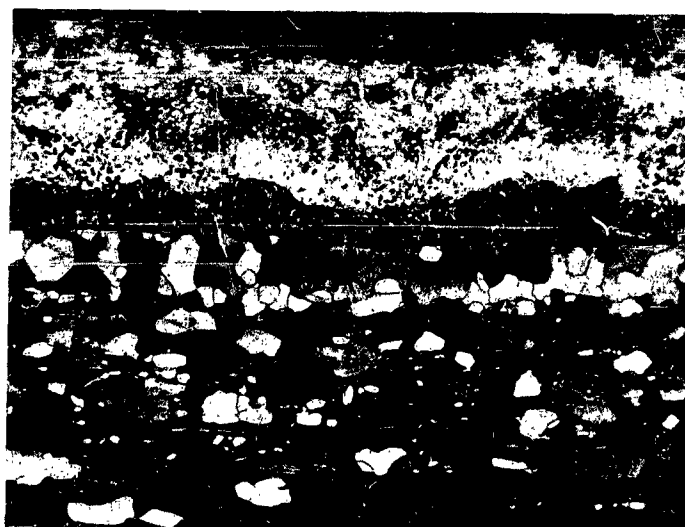
A. Diffusion Treated Two Hours in
Purified Hydrogen at 2000°F

B. Stressed for 27 Hours in Air
at 1800°F

FIG 19 - MICROSTRUCTURES AT GAGE SECTIONS OF COATED DUCTILITY
TEST SPECIMENS AS DIFFUSION TREATED AND AFTER
STRESSING FOR 27 HOURS IN AIR AT 1800°F

It was observed that the stress required to produce an elongation in the range 2-5% in 100 hours at 1800°F with coated 0.75% vanadium alloy was less for the specimens coated with the Colmonoy alloys than for the specimens coated with aluminum-chromium-silicon composition (see Table 2). Metallographic examination of specimens, before and after testing, revealed a phenomenon which may explain this observation. The Colmonoy-coated specimens exhibited complete recrystallization of the 0.75% vanadium-molybdenum alloy in a narrow zone adjacent to the coating. This is shown in Figures 19 and 20 with specimens as-diffusion treated, and after testing under stress for 27 and 136 hours, respectively, at 1800°F. The photomicrographs show that, as-diffusion treated, the specimen had a narrow recrystallized zone, and that the width of the recrystallized zone increased with increase in exposure time at 1800°F.

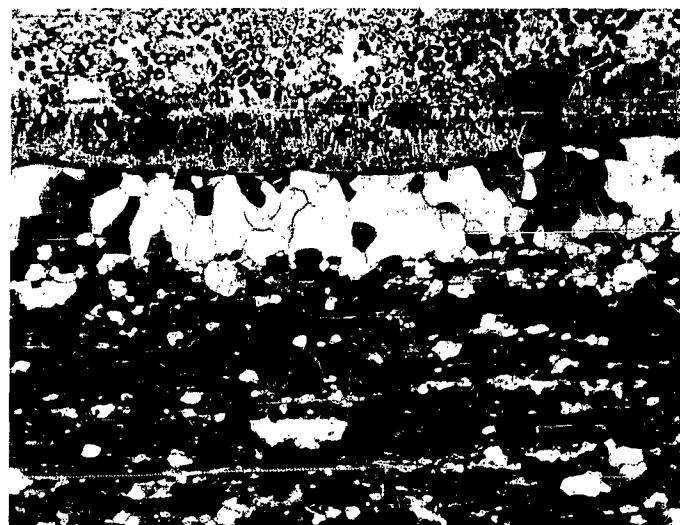
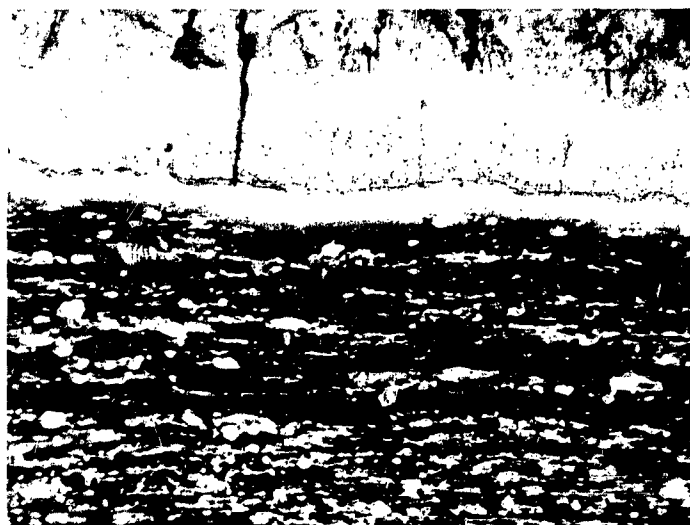
FIG 20 - MICROSTRUCTURES AT GAGE SECTIONS OF COATED DUCTILITY
TEST SPECIMENS AFTER STRESSING FOR 100+ HOURS IN AIR
AT 1800°F, showing effect of coating composition on
recrystallization of 0.75% vanadium-molybdenum alloy

Colmonoy No. 6
Coating

V-Mo Alloy

M3160 Etchant: $\text{NaOH} + \text{K}_3\text{Fe}(\text{CN})_6$ 250X

A. Stressed for 136 Hours in Air at
1800°F. Colmonoy No. 6 Coating

Al-Cr-Si
Coating

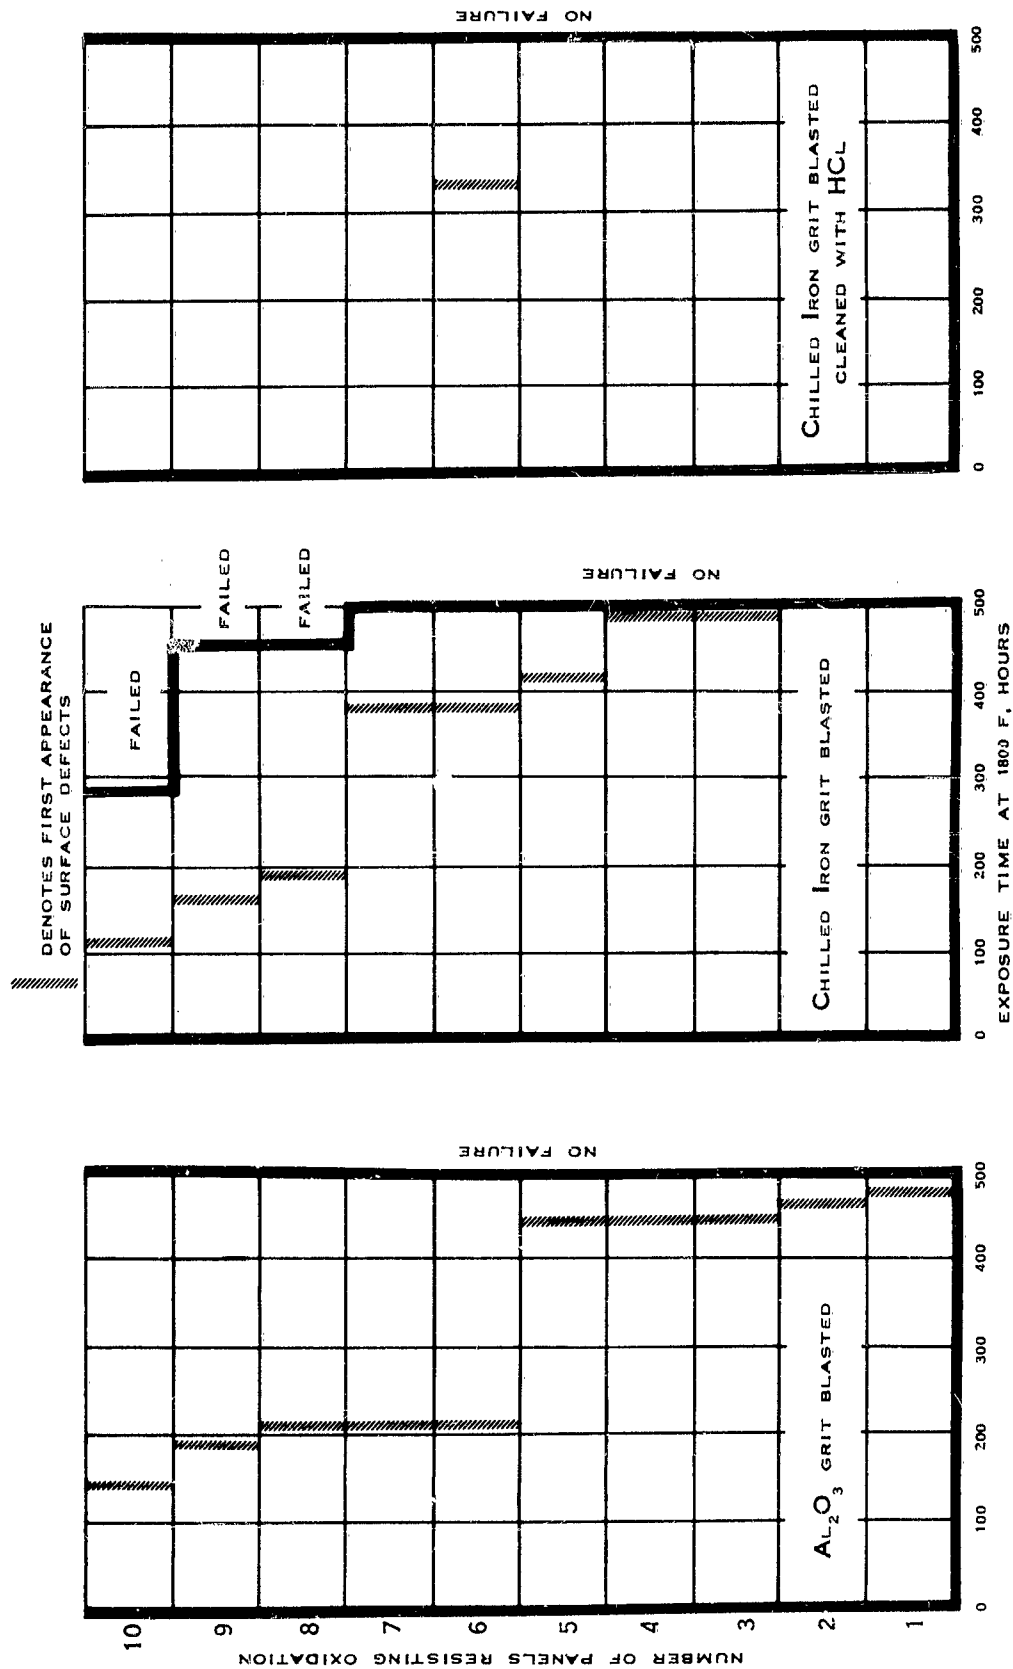
FIGURE 21 - EFFECT OF SURFACE PREPARATION UPON RESISTANCE TO OXIDATION AT 1800 F

ONE LAYER 0.010" AL-CR-SI SPRAY COATING

Originally the molybdenum test panels were blasted with aluminum-oxide grit to prepare the surfaces for coating. Occasionally SAE Grade G-25 iron grit was employed. Both types of grit were found to produce satisfactory roughening of the surfaces to facilitate mechanical bonding. Meticulous metallographic examination of coatings which had been subjected to oxidation testing led to the discovery that particles of aluminum-oxide grit often became embedded in the surface of the molybdenum panels and were subsequently covered over by the sprayed metals. The presence of the aluminum oxide interfered with the formation of the diffusion zone between the coating metals and the molybdenum substrate. Since there was some evidence that the diffusion zone was important to the effectiveness of the coating, it was suggested that the grit particles could be a cause of coating failures. Metallographic observations of as-sprayed panels revealed that the iron grit also became embedded in the molybdenum, but no iron grit could be found in coated panels that had been diffusion treated. Failure to find the particles in panels after the diffusion treatment and/or the oxidation tests did not remove the suspicion that they were a cause of coating failure. By experiment, however, it was found that embedded iron grit particles could be removed by treating the grit blasted panel with concentrated hydrochloric acid. No satisfactory method of removing embedded aluminum oxide grit was developed.

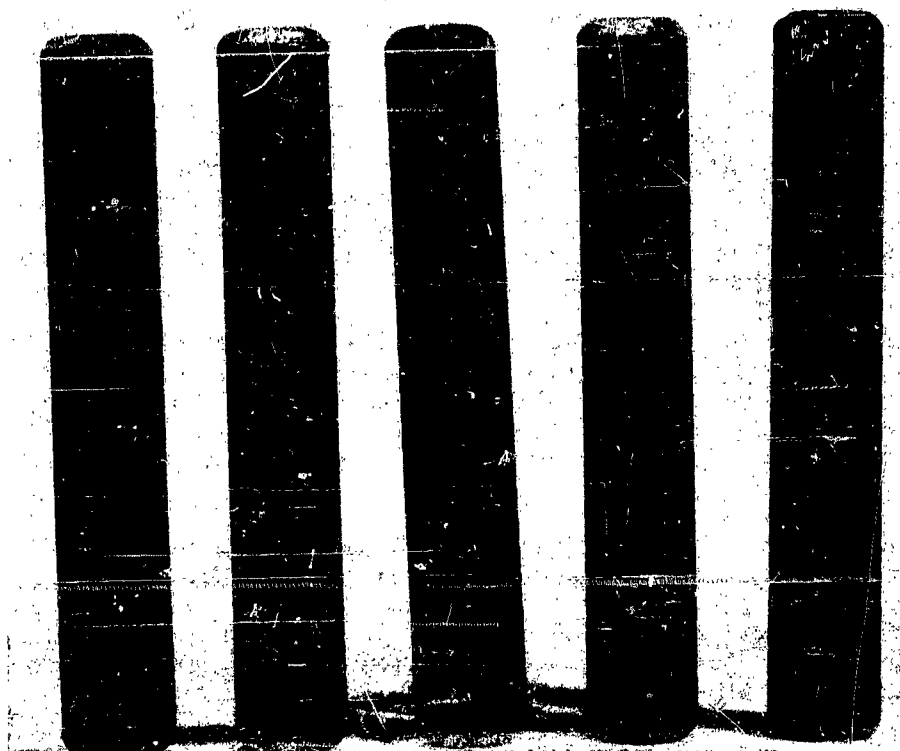
FIG 25 (P1138)

MOLYBDENUM BARS HAVING 0.005 IN. THICK MECHANICALLY FINISHED
Al-Cr-Si COATING, AFTER EXPOSURE TO AIR FOR 500 HOURS AT 1800°F
